Re: Notice of Violation  
RCRA Compliance Evaluation Inspection – Chicago Transit Authority  
EPA ID No.: ILD 984 774 117

COMPLIANCE EVALUATION INSPECTION REPORT

**INSTALLATION NAME:** Chicago Transit Authority  
**U.S. EPA ID. No.:** ILD 984 774 117  
**LOCATION ADDRESS:** 711 S. Des Plaines Avenue  
Forest Park, Illinois 60130  
**DATE OF INSPECTION:** February 17, 2016  
**U.S. EPA INSPECTORS:** Sheila Burrus, RCRA Hazardous Waste

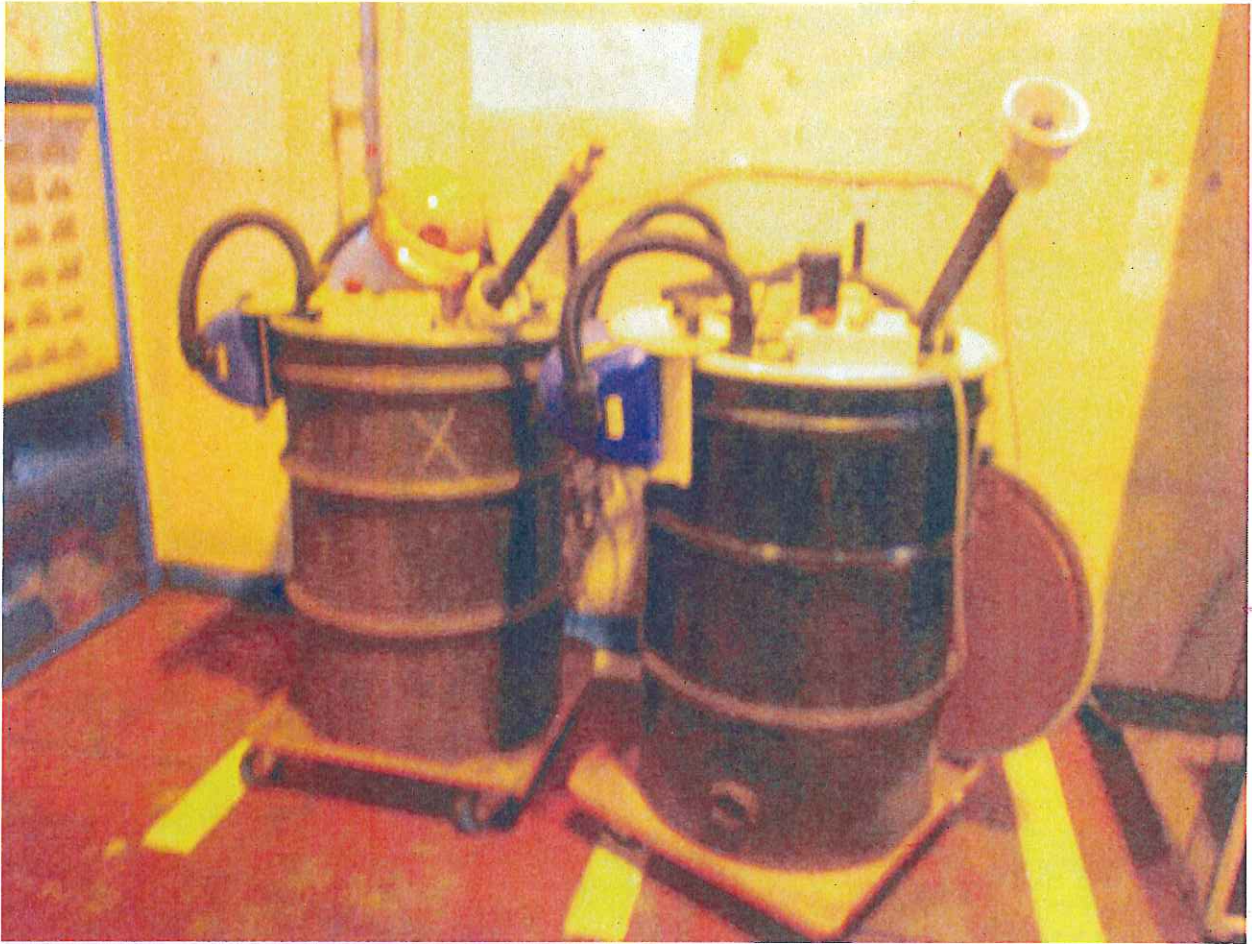
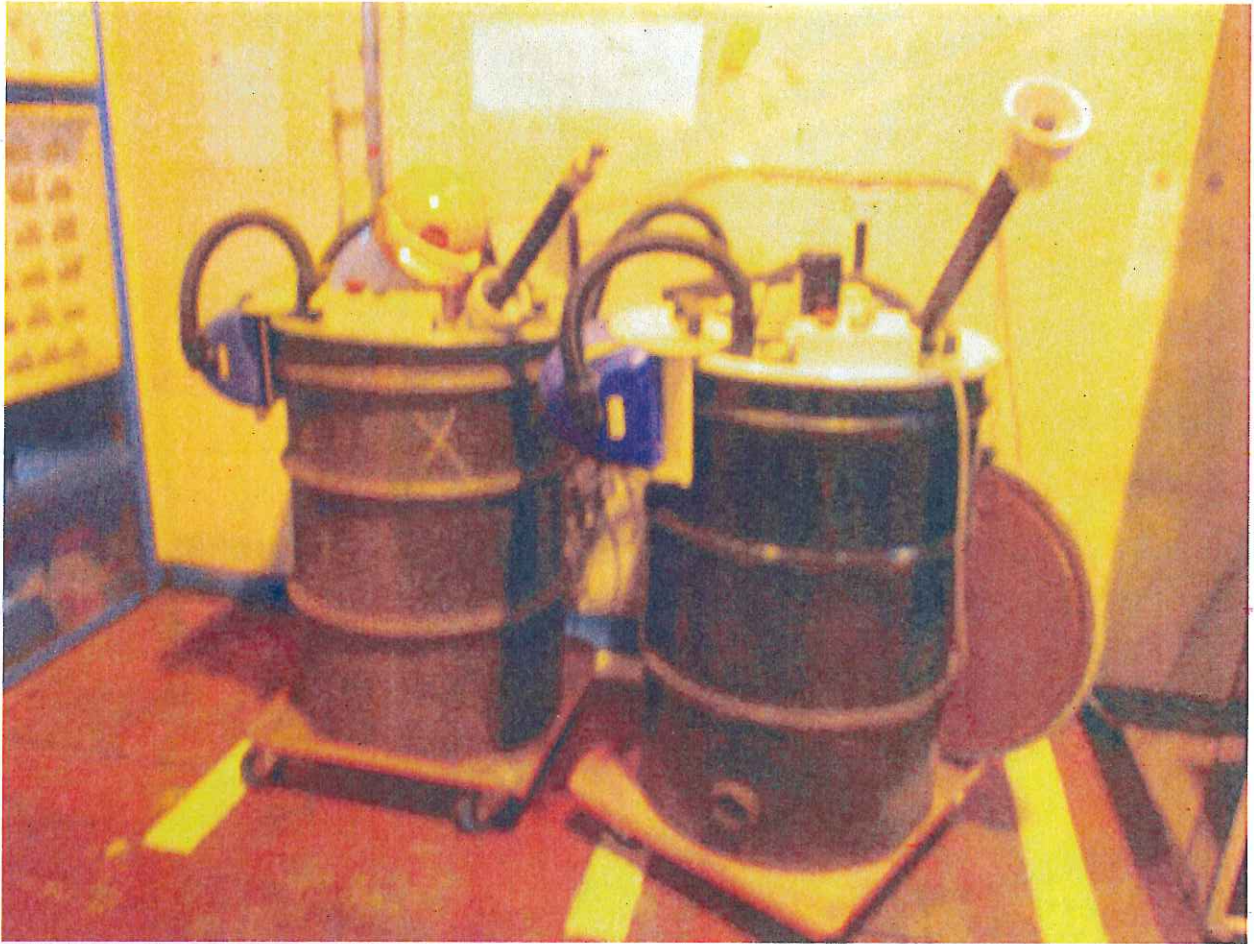
Next we proceeded to the waste lamp crusher which is located on the north side of the facility. I observed two unlabeled 55-gallon waste lamp crushers (one of the containers was empty (Photograph 2). Mr. Webber stated that it takes appropriately 1 year to fill a 55-gallon drum of crushed waste lamps.

PHOTOGRAPH: 2  
NAME OF PHOTOGRAPHER: Sheila Burrus  
DATE OF PHOTOGRAPH: February 17, 2016  
LOCATION OF PHOTOGRAPH: northside of building  
SCENE BEING PHOTOGRAPHED: Bulb Crusher  
SITE LOCATION: 711 S. Des Plaines Avenue  
Forest Park, IL 60130  
INSTALLATION NAME: Chicago Transit Authority  
INSTALLATION I.D. #: ILD 984 774 117

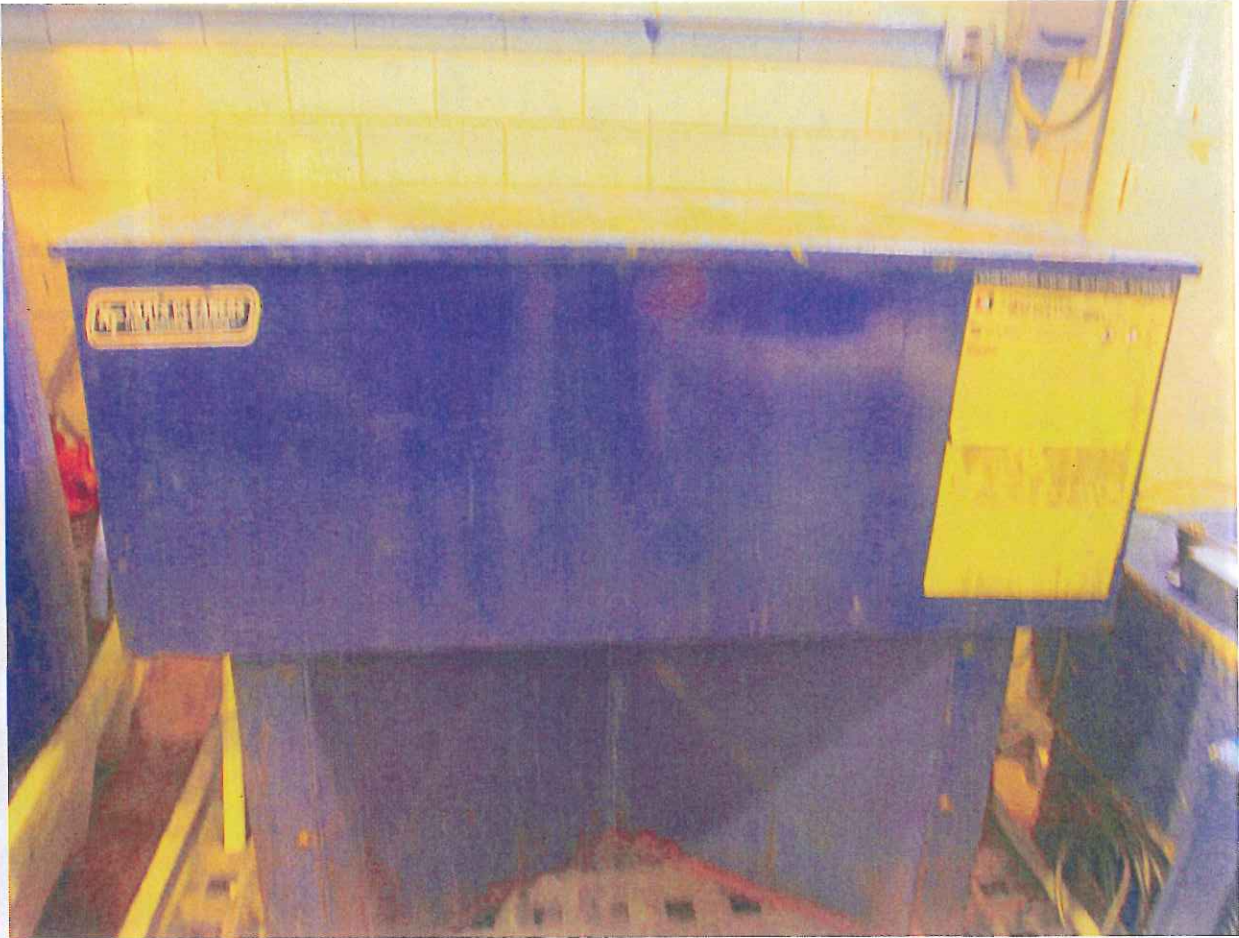
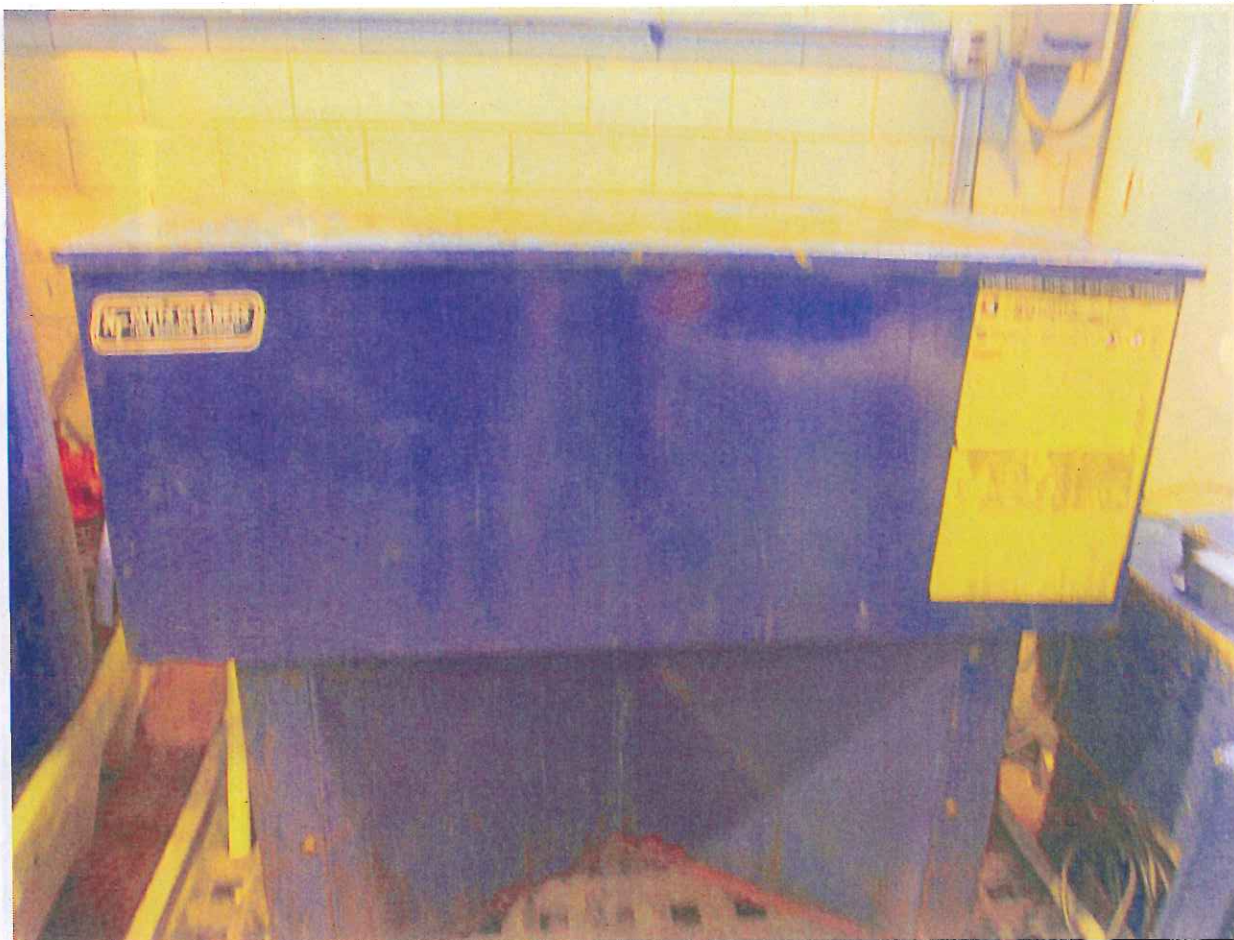
PHOTOGRAPH: 3

After inspecting the waste lamp crusher we proceeded to the parts washer which generates non-hazardous waste mineral spirits from the cleaning of small parts (Photograph 3). The facility did not have any hazardous waste on-site at time of the inspection.

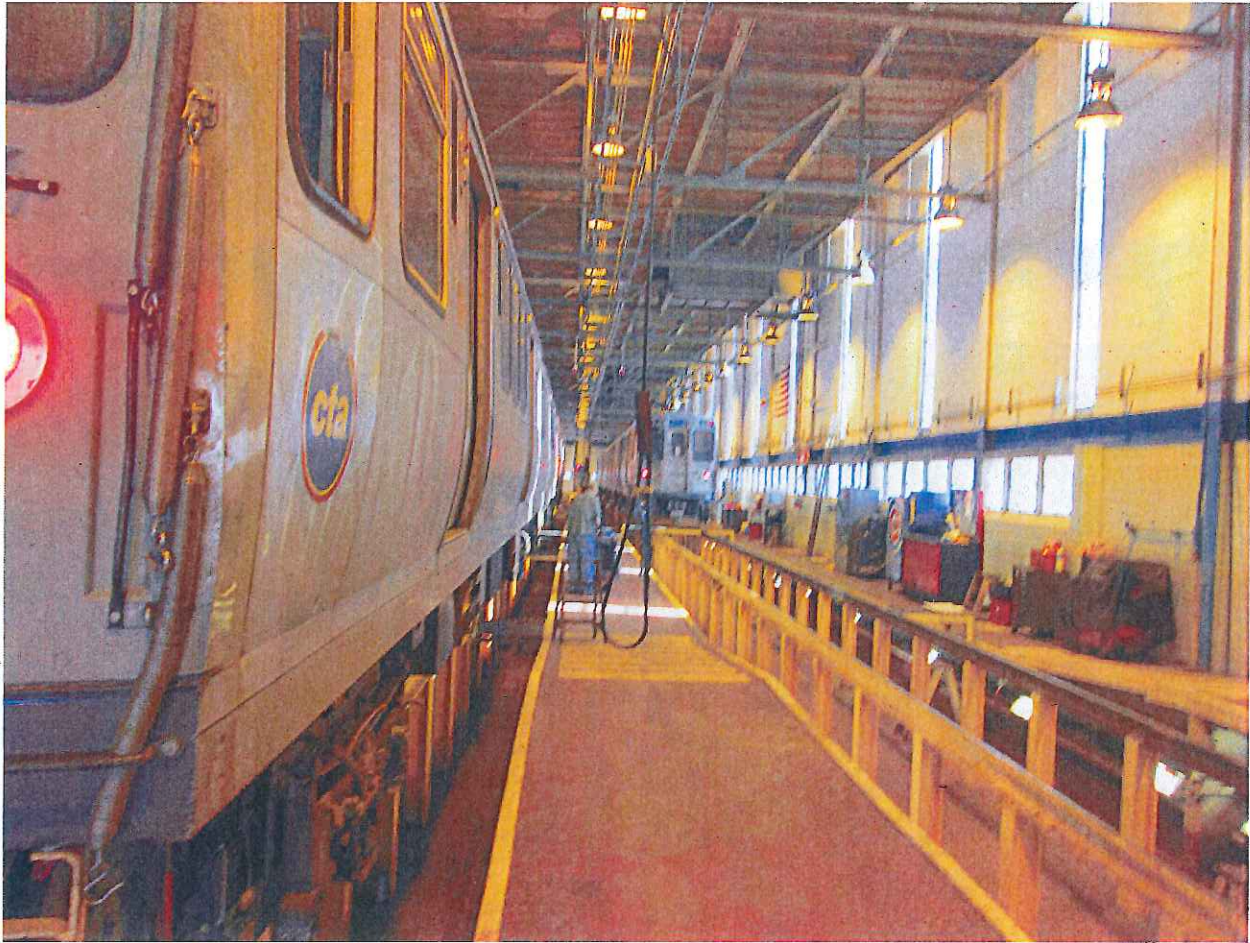
PHOTOGRAPH: 4  
NAME OF PHOTOGRAPHER: Sheila Burrus  
DATE OF PHOTOGRAPH: February 17, 2016  
SCENE BEING PHOTOGRAPHED: rail-car maintenance facility  
SITE LOCATION: 711 S. Des Plaines Avenue  
Forest Park, IL 60130  
INSTALLATION NAME: Chicago Transit Authority  
INSTALLATION I.D. # ILD 984 774 117
